MODERNIZING A LUMBER PRODUCTION ENVIRONMENT WITH HONEYWELL SLATE AND THERMAL IQ SOLUTIONS

Case Study

Honeywell and channel partner Martin Control & Equipment Company helps a leading U.S. lumber company upgrade its 30-year-old kiln to satisfy sold-out demand and avoid over \$200K in lost production.

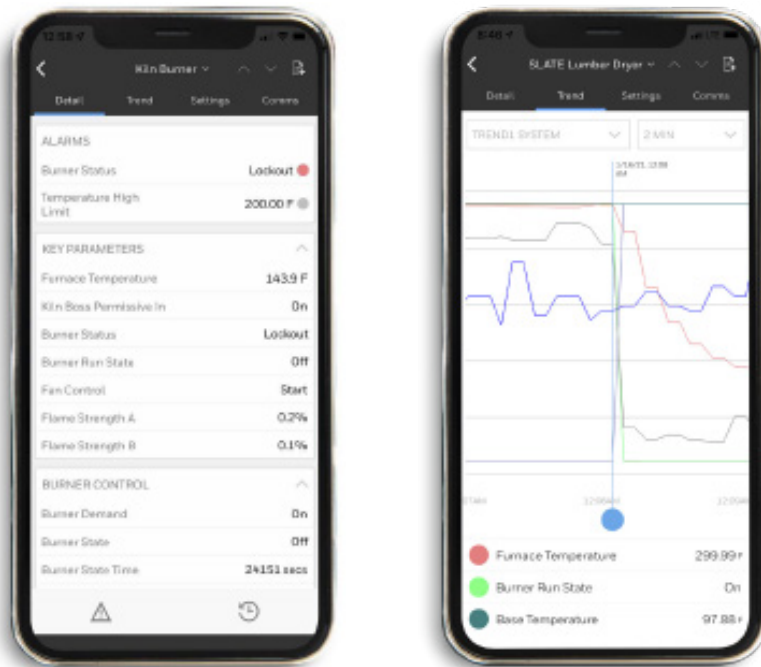
Real-time monitoring and alerts drove visibility to the remote Martin Control team.

The teams were able to compare operating parameters to better understand what was occurring prior to and after the lockout for enhanced troubleshooting.
